4.1 SITE ASSESSMENT

The Charlotte Central School contracted with Dore and Whittier Architects, Inc. to perform a comprehensive review of the school facilities and make recommendations with regard to structure and system improvements. Donald L. Hamlin Consulting Engineers has provided civil engineering and permit compliance assistance to the Charlotte Central School for over 20 years and so was retained directly by the school for the civil/site portion of the review due to their in depth knowledge of the site and systems outside of the school building. The following is a summary of their recommendations related to grounds and systems outside of the building envelope.

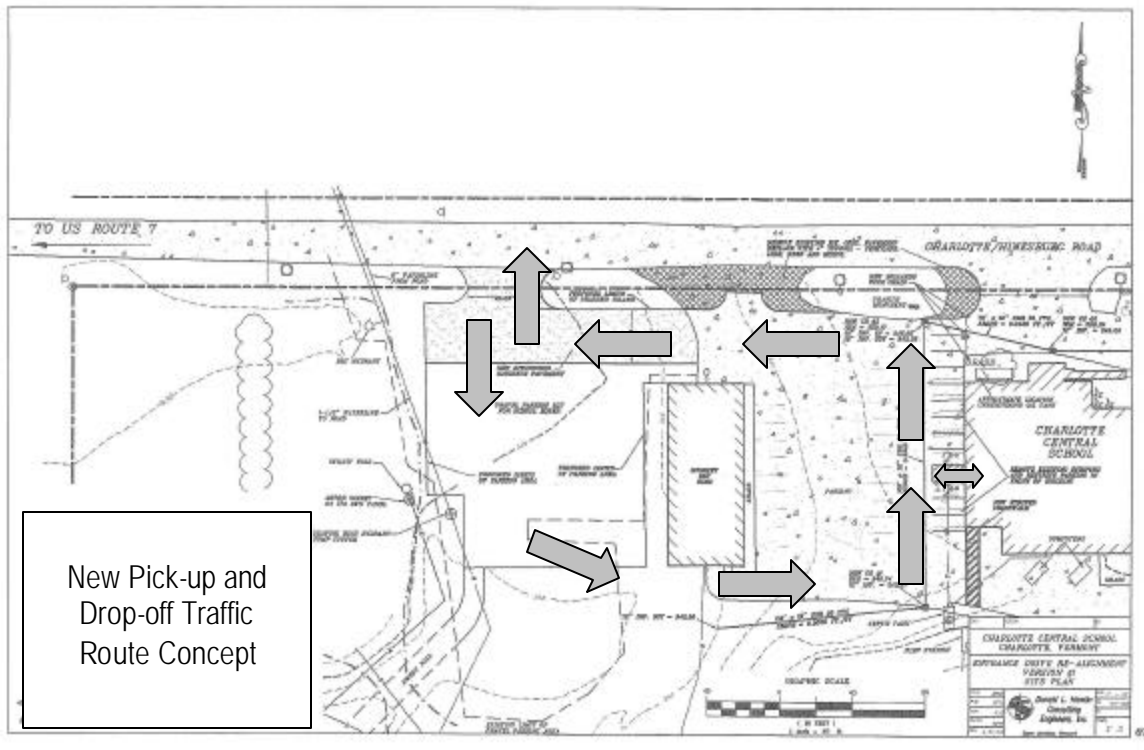
Parking and Site Circulation – During each of the past several building additions, modifications to the drive and parking areas have been made. The most recent of these changes were made as a part of the 1996 building additions and included closing an existing curb cut and modifying the site circulation to separate auto traffic from bus traffic during the beginning and end of the school day. The Charlotte Central School presents a particularly difficult challenge for site drives and traffic circulation due to steep slopes on the public roadway which hamper site distances at the drives and also the limited distance between the front of the school and the public street. Based upon conversations with Head Custodian Labonte, it appears that there is adequate parking to serve the school staff and daily visitors to the school. One deficiency that has been identified is related to the site traffic that results from parents either picking up or dropping off students. These vehicles must circulate through both parking aisles of the west parking area in order to reach the school's western access door. This creates conflicts with those wishing to park and also requires students to pass between other parked vehicles. One potential solution to reduce these conflicts would be to re-route the pick-up and drop-off traffic by creating a one way lane that would start at the most westerly curb cut, go south along the west side of the Quonset hut, then south of the quonset hut reaching the southern edge of the western parking lot joining the existing parking lot aisles that would lead to the westerly school entrance door. If four or more parking spaces were eliminated from immediately adjacent to the entrance door, a curbed island and walk could be constructed to join the drop off location with the door. This island would provide a safe haven area for students who have been dropped off or are waiting to be picked up. This would have the added benefit of making those students more visible to parking lot traffic. Further study is required to determine if the one way lane configuration can be constructed to meet the required turning movement radii for passenger vehicles and to insure that this lane will not conflict with the bus parking area use. See schematic plan below:
